ASARCO EAST HELENA SMELTER
2006 INTERIM MEASURES WORK PLAN ADDENDUM

2006 PHASE 1, PHASE 2 AND PHASE 3
FINAL CLEANING, SOIL SAMPLING, BACKFILLING, AND
INTERIM CAP WORK PLAN

September 26, 2006

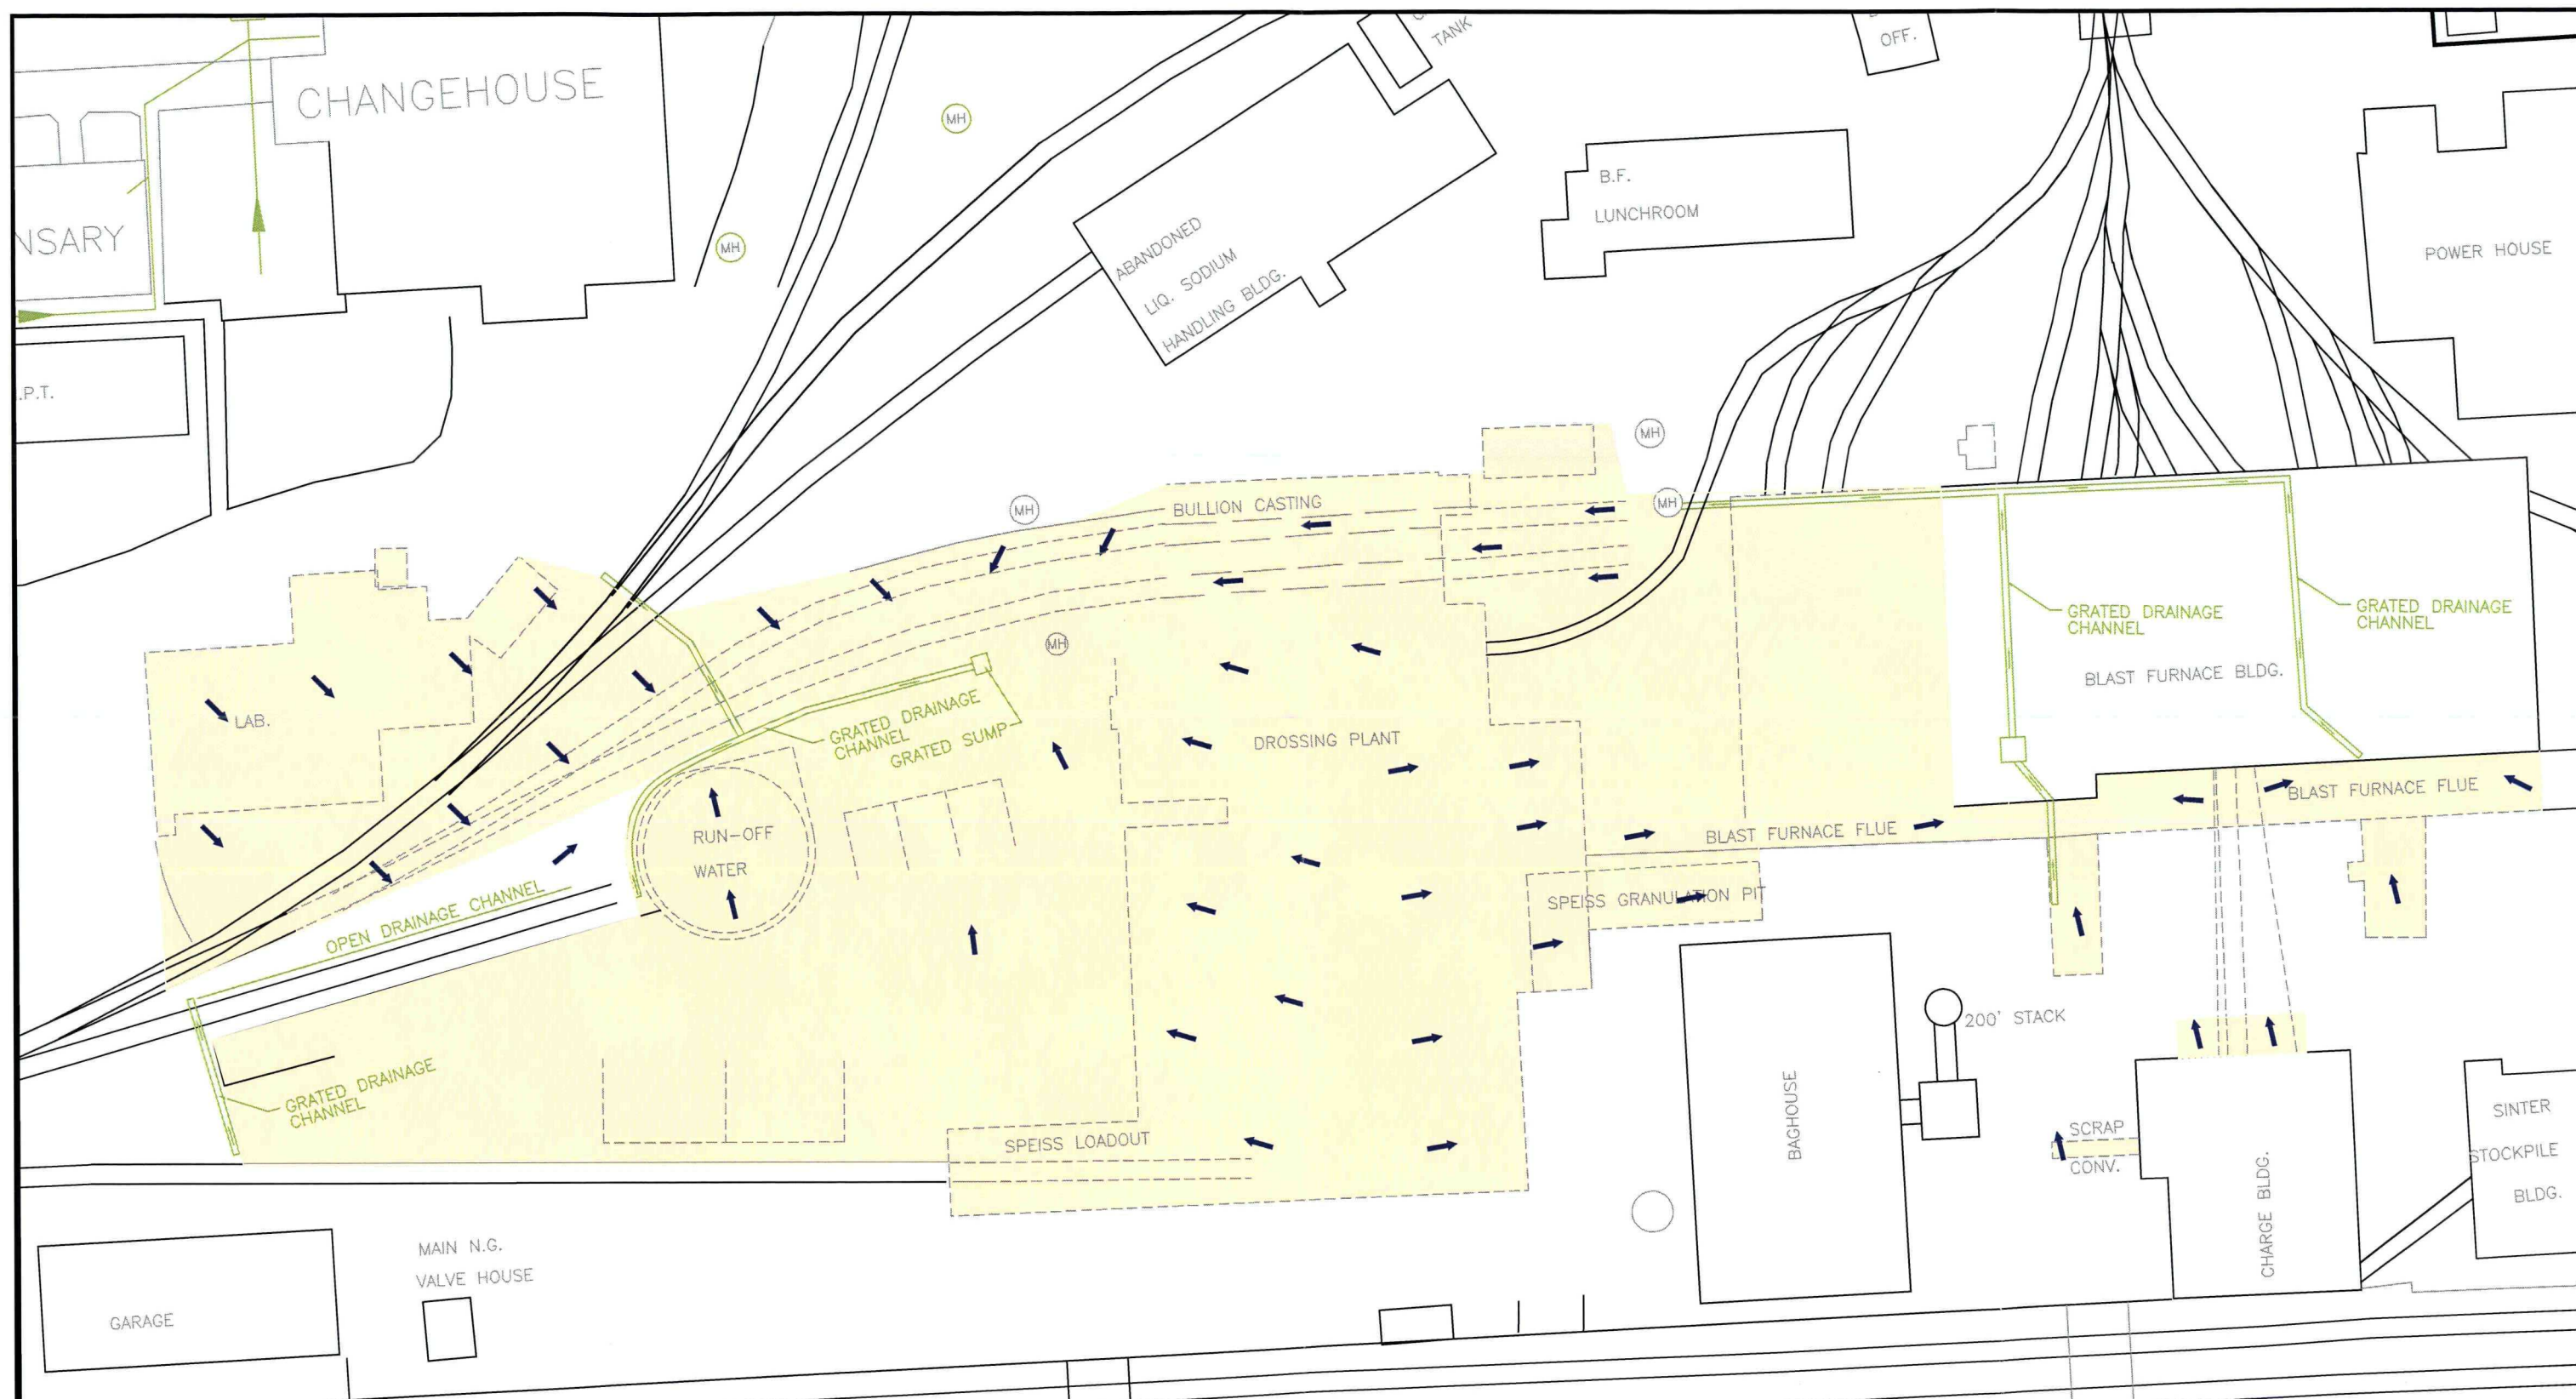
**FIGURE
2-2**

- SURFACE WATER DRAINAGE INLET AREAS (GRAVITY FLOW)
- ESTIMATED INTERIM CAPPED AREAS
- ➔ SURFACE WATER DRAINAGE FLOW IN INTERIM CAPPED AREAS

**PHASE 2 DEMOLITION AREAS,
SOIL SAMPLING SITES (PENDING),
INTERIM CAP,
AND DRAINAGE PLAN**

Once the required backfilling has occurred, the demolition areas will be covered to control drainage, and to control the potential for infiltration of precipitation and run-on within the newly exposed footprints in the Phase 1, 2, and 3 areas. The demolition and drainage plans for Phases 1, 2, and 3 areas are shown in Figures 2-1, 2-2, and 2-3.
